*Source Control Evaluation Addendum
Operable Unit 2
Swan Island Upland Facility
Portland, Oregon*

Prepared for:
Port of Portland

December 27, 2011
1115-05

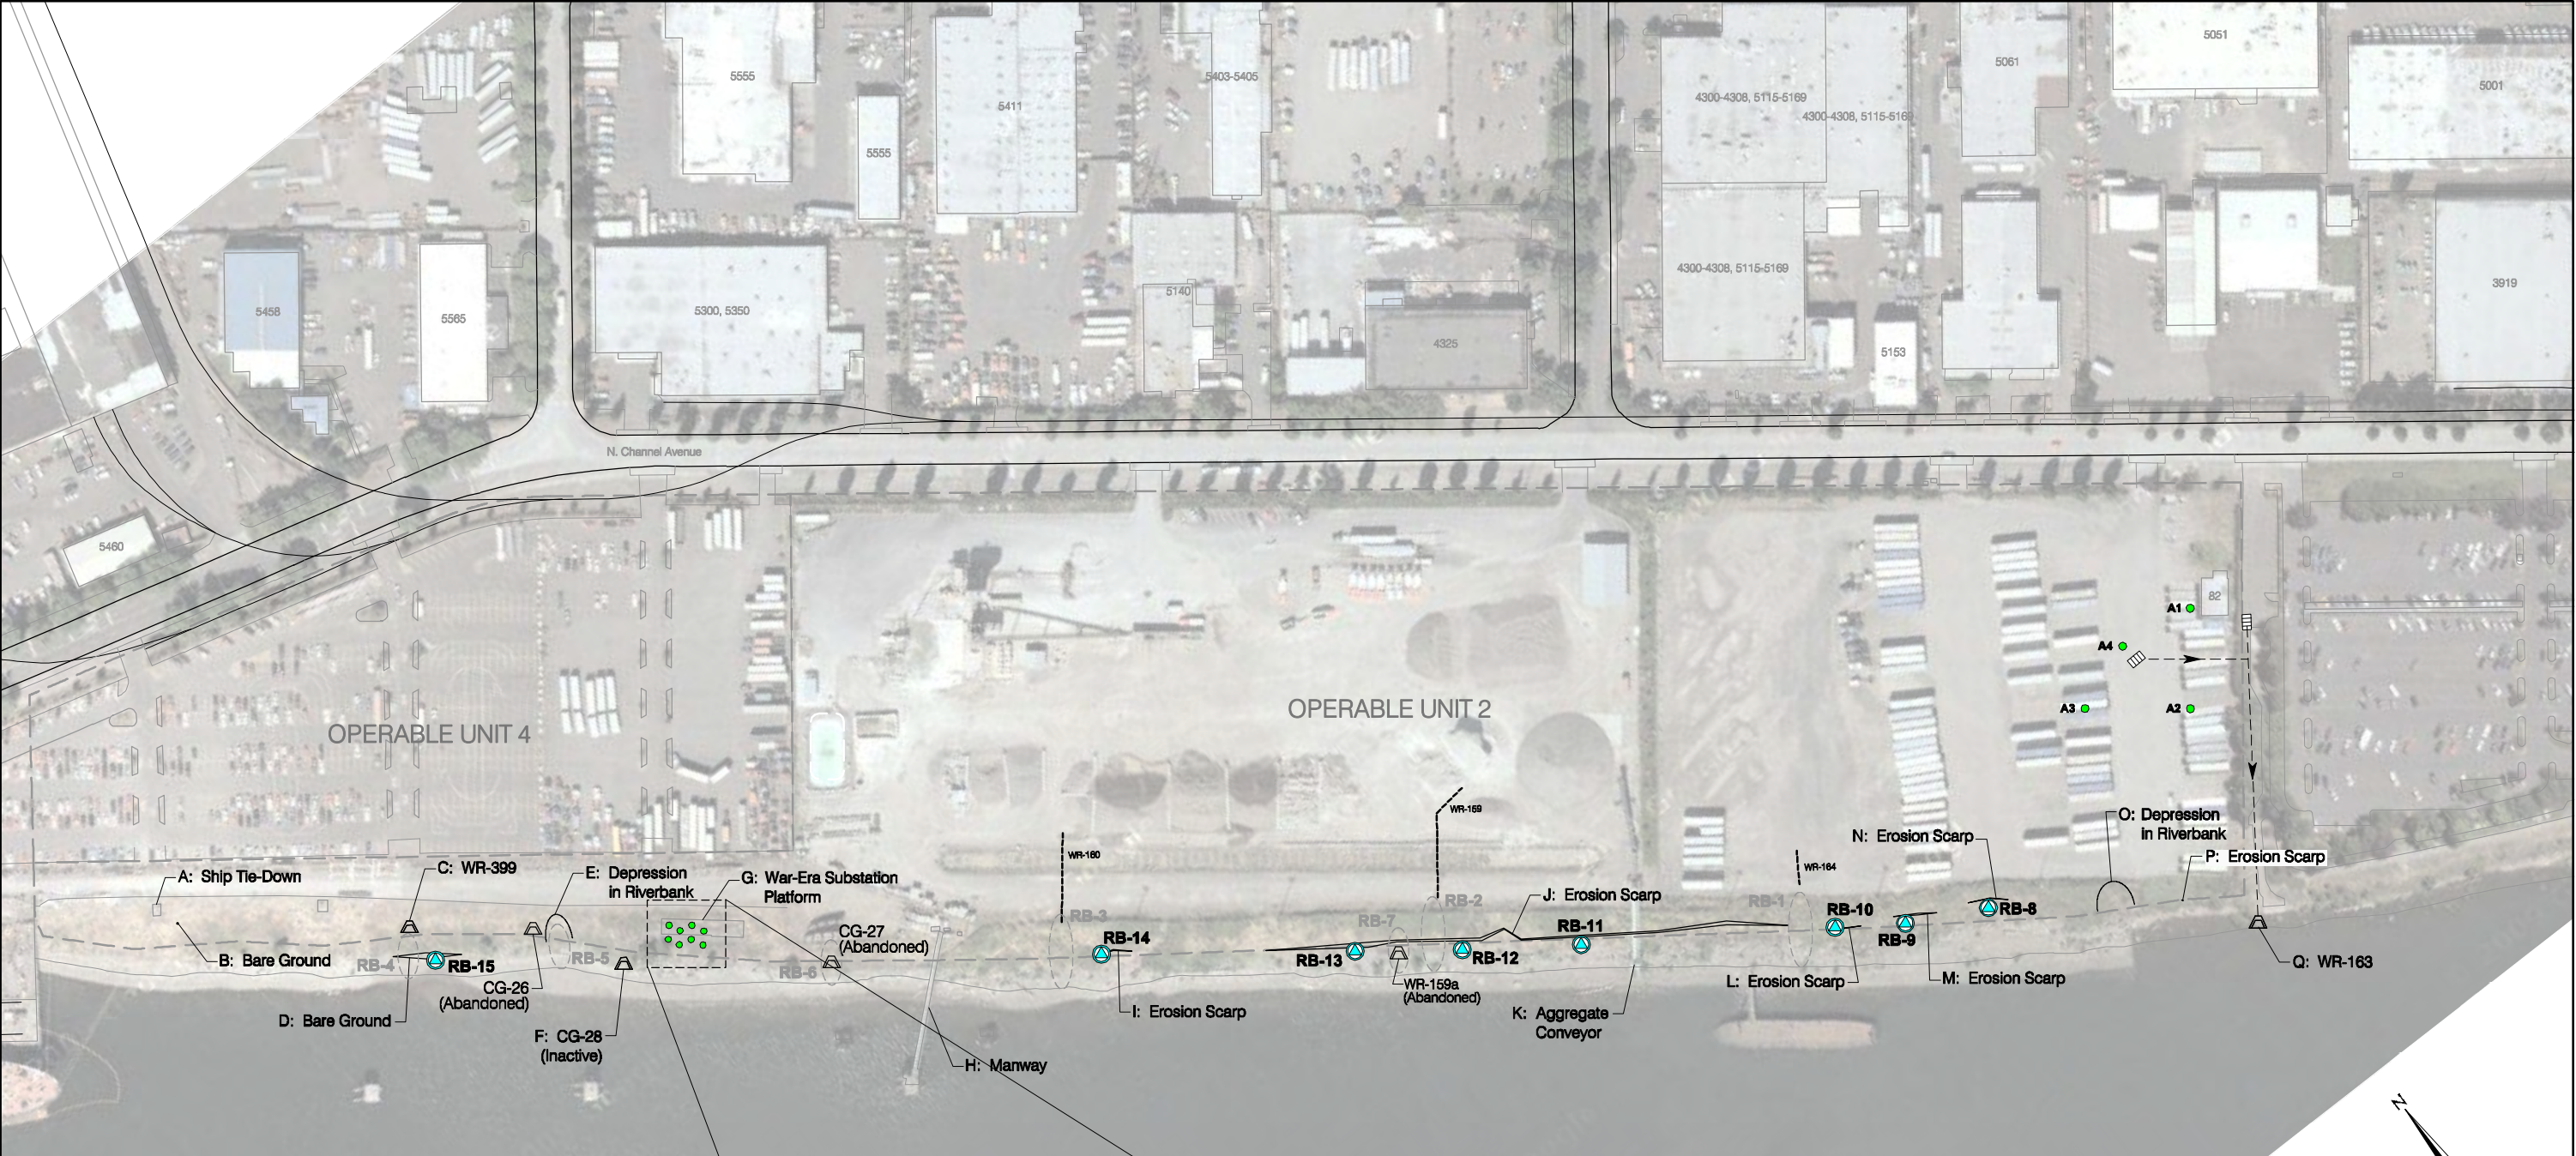
**Riverbank Reconnaissance and
Soil Sampling Plan**

Locally, various surface features (designated A through Q) were observed and mapped. The location and ground elevation of observed erosion features were surveyed by a licensed surveyor. The observed features are identified on Figure 3 and discussed below.

In summary, the riverbank is characterized by dense vegetation with 17 observed surface features. Six of these features are structures (C, F, G, H, K, and Q). In addition, two features consist of historical bank disturbance (some associated with historical outfalls no longer present) but the surface is now densely vegetated and there was no evidence of current erosion (E and O). Two features (A and B) are bare ground high on the bank with a total surface area of approximately 30 square feet. One feature (D) consists of bare ground (total surface area of approximately 240 square feet) apparently associated with outfall WR-399. Finally, six features consist of visible erosion scarps (I, J, L, M, N, and P). The erosion scarps are discussed further below.

The erosion scarps are linear features running parallel to the riverbank. They are located at or above the transition from rip rap to vegetated riverbank. The total length of the scarps is 830 feet (or 30 percent of the total bank length). Of that total, approximately 300 feet of the scarps encroach below the OLHW (toe elevations ranging from 15.0 to 16.6 feet NGVD). As discussed in Sections 3.4 and 3.5, overland flow and river action are not likely causes of the observed erosion. Instead, the observed characteristics of the erosion are consistent with erosion resulting from wave action (caused primarily by boat wakes). The majority of the riverbank is covered with rip rap or dense vegetation and has no evidence of erosion, demonstrating that rip rap and vegetation are effective. It is likely that the erosion scarps originated in areas with a poor transition from rip rap to dense vegetation. For example, if the top elevation of the rip rap is below the OLHW in a particular location, upland vegetation at that transition may struggle to sustain dense growth from year to year. If, during a down year for vegetation, the river level is sustained at a level just above the rip rap, boat-wake action could initiate erosion that leads to a small vertical scarp. As long as the water level is above or below the location of the erosion scarp, no substantive erosion would occur. Whenever the water level is at the level of the scarp, however, the bank would be subject to additional erosion. Observations of the riverbank support this model. For example, at multiple locations, the vegetation has become well-established below the location of the erosion scarp (see Photographs 43 and 44). This indicates that at least one to two growing seasons passed without substantial erosion of the scarp.

The location of the largest erosion scarp (J) is roughly centered on the aggregate barge conveyor serving the Cemex facility. The Cemex facility began operation in 2007. The most recent prior reconnaissance of the riverbank was conducted in October 2005 in association with the ecological risk assessment for OU2. The erosion scarp at feature J observed in 2010 was not observed at the time of the 2005 reconnaissance, suggesting that the bulk of the erosion associated with that feature occurred after 2005. This further suggests that much of the erosion may be associated with the movement of barges in and out of the mooring location.

Based on the presence of metals, PAHs, TBT, and PCBs above SLVs in riverbank soil, and the potential for erosion of the riverbank, a source control alternatives evaluation is recommended.
